**Flood Control Project Maintenance  
Levee Inspections**

## Maintenance Issue Types Only, Levee Inspection Report By Mile - Spring 2018

### Reclamation District No. 2064 River Junction

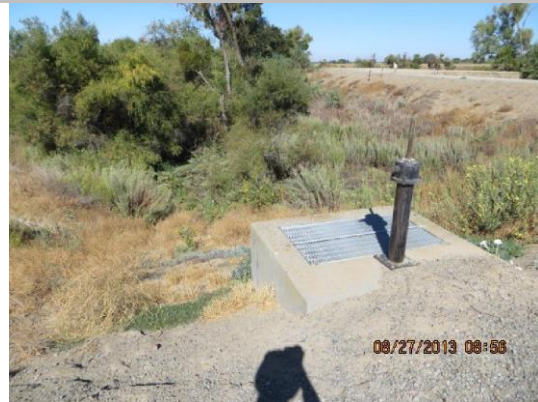
Photo 1 of 3 : UCIP\_SP\_2018\_43603\_31258.jpg

| FS_ID:43603<br>DS_ID:20511<br>EP_NO: N/A<br>Repair Type: No Action Needed<br>Crossing Status: Found<br>UCIP Comments: Debris removed from flap gate on waterside tow<br>FIELD_STRUCT_DESC: 36-inch by 36-inch reinforced concrete box drainage culvert through the levee, 21 feet below the crown. Concrete U-shaped headwalls on both ends. Slide gate in a 6-foot by 7-foot concrete riser on the waterside (WS) slope. Flap gate on the WS end. Flashboard slots on the landside (LS) headwall. [Additional Reference(s): DWR Levee Log, 2005. USACE San Joaquin O&M Manual 3, December 1968, (HLM 0.07)].<br>FS Date: 3/2/2015 | | | | | |

Slide gate in concrete riser on WS shoulder.

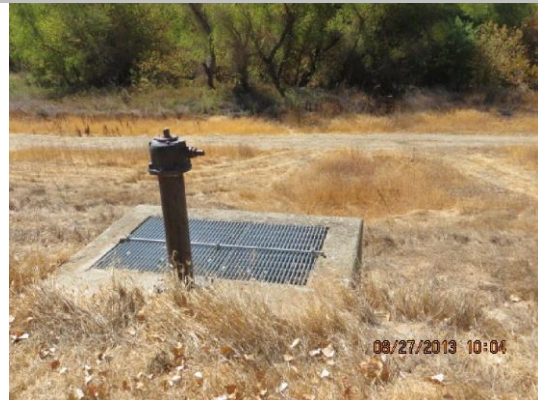
Photo 1 of 3 : UCIP\_SP\_2018\_18763\_31402.jpg

| FS_ID:18763<br>DS_ID:20515<br>EP_NO: N/A<br>Repair Type: Non-Urgent<br>Crossing Status: Found<br>UCIP Comments: Culvert filled nearly to the top with soil.<br>FIELD_STRUCT_DESC: 30-inch by 30-inch reinforced concrete box drainage culvert through the levee, 14.7 feet below the crown. Slide gate in a concrete riser on the waterside (WS) slope. Concrete U-shaped headwalls on both ends. Flap gate on the WS end. [Additional Reference(s): DWR Levee Log, 2005. USACE San Joaquin O&M Manual 3, December 1968, (HLM 1.93)].<br>FS Date: 8/27/2013 | | | | | |

Slide gate in Concrete riser on WS shoulder.

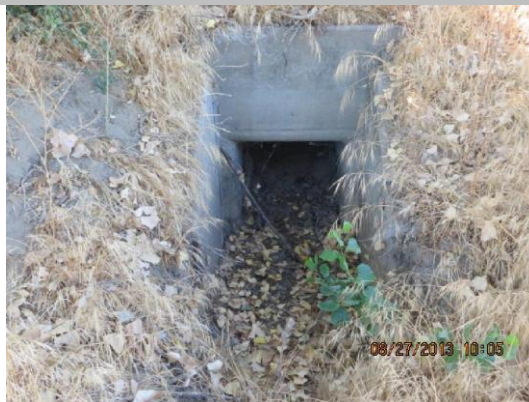
Photo 3 of 3 : UCIP\_SP\_2018\_18763\_31400.jpg

Concrete U-shaped headwall on LS toe.

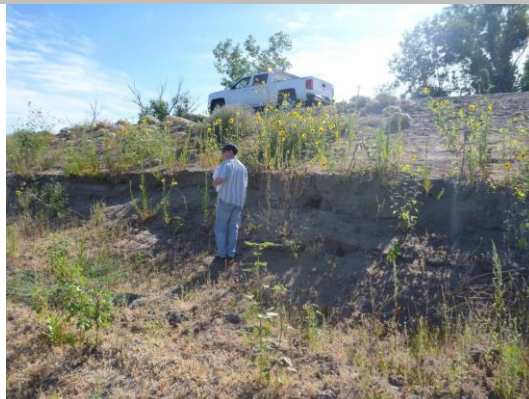
Photo 1 of 3 : SP\_2018\_RD2064\_313\_22\_20180329\_00005.jpg

| Levee Evaluation Comments<br>Description:Erosion from high water flows caused erosion scarps from 12" to 30" in height. The area of damage is approximately 400 feet in length.<br>Site ID No:582<br>Site Designation:LMA-488<br>Repair Type: Erosion<br>Rating:Serious<br>Field Date:8/14/2017<br>Notes: | | | | | |

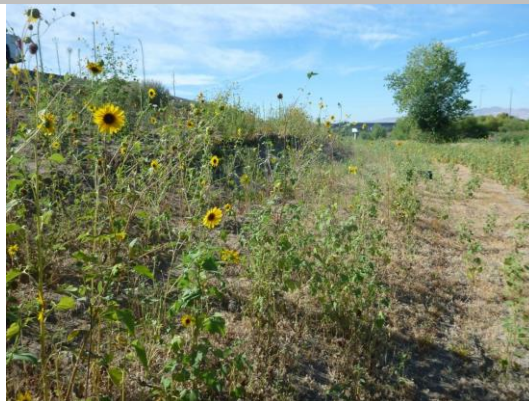
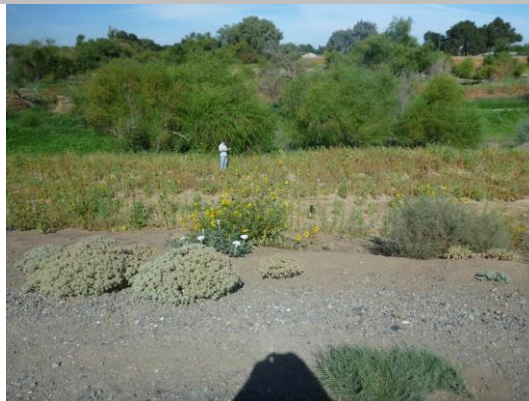
| Description:Erosion from high water flows caused erosion scarps from 12" to 30" in height. The area of damage is approximately 400 feet in length. | | | | | |

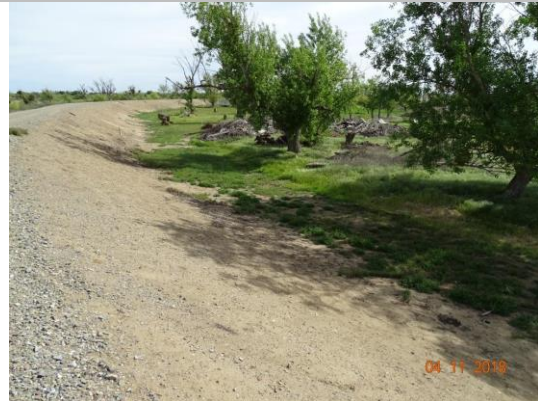
Photo 1 of 1 : SP\_2018\_RD2064\_313\_10\_20180411\_00069.jpg

| Significant baiting has greatly reduced rodent activity. Two small borrow/mounds observed. Control program should continue due to nearby slash pile. | | | | | |

View of former landside rodent area and slash pile in distance. Rodent control program has largely mitigated the problem, but should continue.

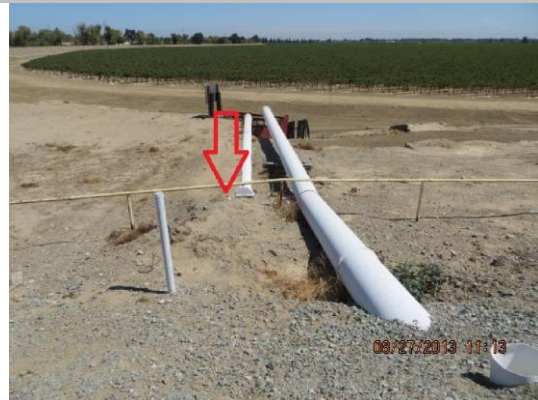
Photo 1 of 2 : UCIP\_SP\_2018\_22732\_38465.jpg

Pipe visible on LS toe.

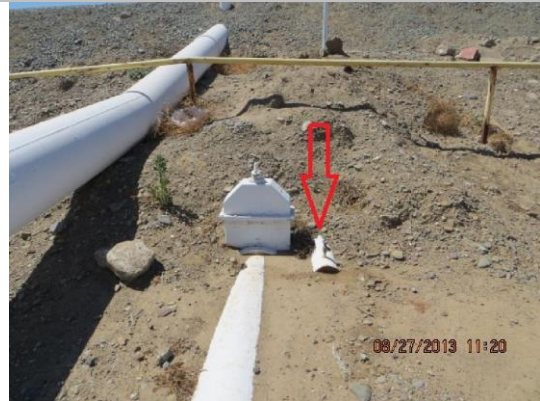
Photo 2 of 2 : UCIP\_SP\_2018\_22732\_38464.jpg

| FS_ID:22732<br>DS_ID:20525<br>EP_NO: N/A<br>Repair Type: Non-Urgent<br>Crossing Status: Found<br>UCIP Comments: Need to determine if pipe was actually removed from levee.<br>FIELD_STRUCT_DESC: 12-inch steel drainage pipe through the levee, at an unknown depth. Steel plate welded over the landside (LS) end at the LS toe. (Permit No. 6450, 1969 - Reclamation District No. 2064, states it was removed in 1973, but it remains visible on the LS toe).<br>[Additional Reference(s): USACE San Joaquin O&M Manual 3, December 1968, (HLM 3.55)].<br>FS Date: 8/27/2013 | | | | | |

Pipe with welded steel plate over LS end at LS toe.

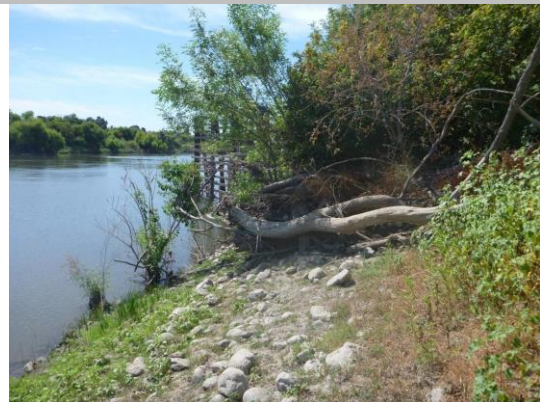
Photo 1 of 3 : SP\_2018\_RD2064\_313\_26\_20180329\_00014.jpg

| Description:Erosion from high water flows caused erosion scarps from 12" to 24" in height. The area of damage is approximately 600 feet in length. | | | | | |
| Notes: Minor toe erosion | | | | | |

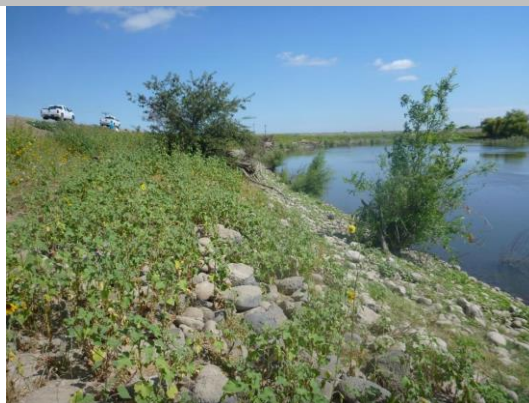
| Description:Erosion from high water flows caused erosion scarps from 12" to 24" in height. The area of damage is approximately 600 feet in length. | | | | | | |
| Notes: Minor toe erosion | | | | | | |

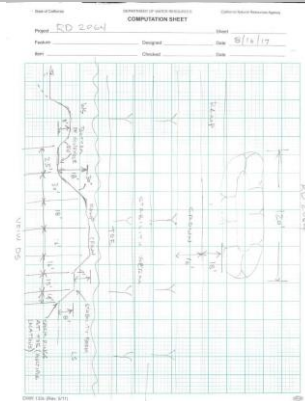
Photo 1 of 1 : SP\_2018\_RD2064\_314\_20\_20180329\_00003.jpg

| Levee Evaluation Comments<br>Description: POI is a waterside sinkhole with an existing seepage berm on the landside. This site was flood fought in 2017 with sack rings.<br>Site ID No: 584<br>Site Designation: LMA-490<br>Repair Type: Stability<br>Rating: Area of Concern<br>Field Date: 8/16/2017<br>Notes: POI is a waterside sinkhole | | | | | |

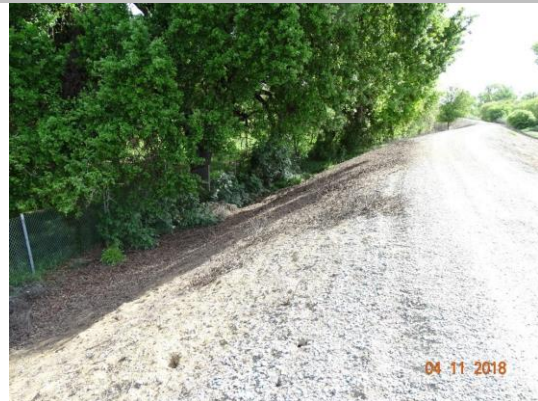
Photo 1 of 1 : SP\_2018\_RD2064\_314\_19\_20180411\_00069.jpg

Landside vegetation along fence should be reduced to allow inspection and access to slope and toe.

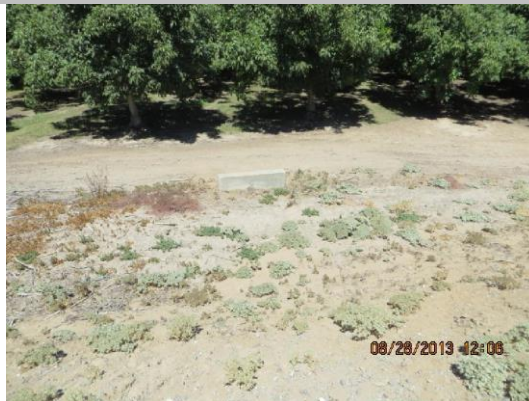
Photo 1 of 3 : UCIP\_SP\_2018\_19117\_32069.jpg

Headwall on LS toe.

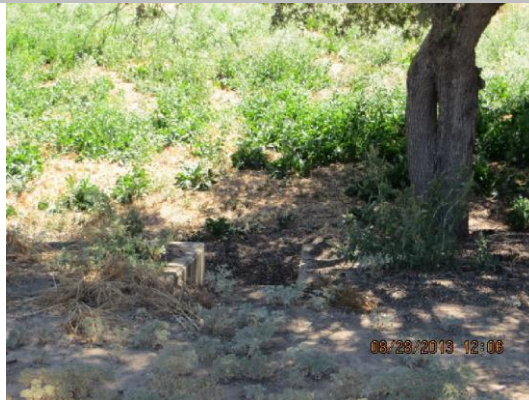
Photo 2 of 3 : UCIP\_SP\_2018\_19117\_32068.jpg

Headwall on WS toe.

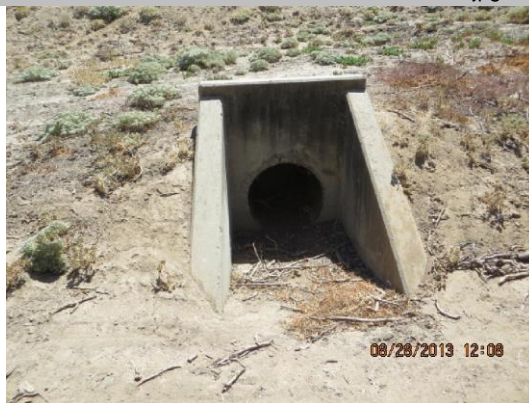
Photo 3 of 3 : UCIP\_SP\_2018\_19117\_32067.jpg

Headwall on LS toe.

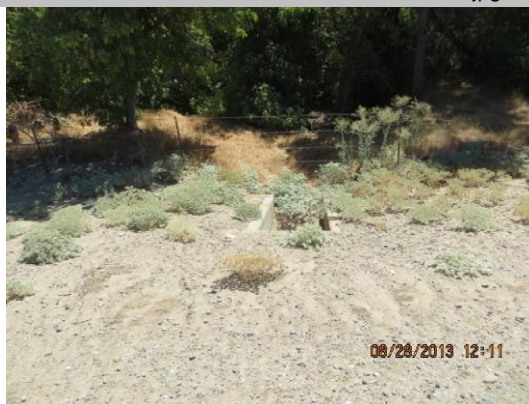
Photo 1 of 3 : UCIP\_SP\_2018\_22793\_38842.jpg

Concrete headwall on WS toe.

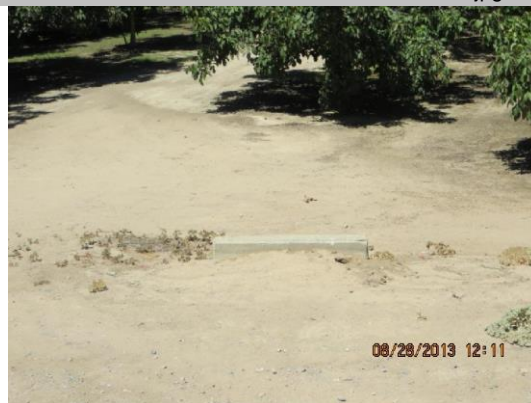
Photo 2 of 3 : UCIP\_SP\_2018\_22793\_38841.jpg

Concrete headwall on LS toe.

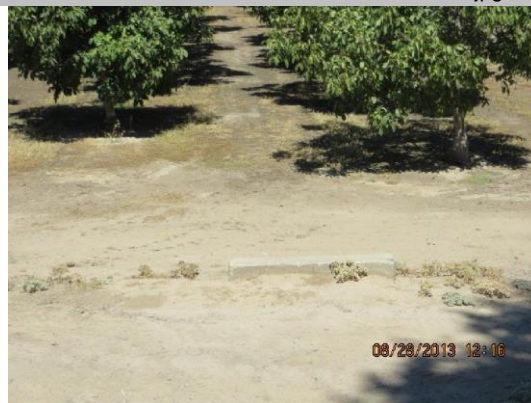
Photo 1 of 3 : UCIP\_SP\_2018\_19120\_32079.jpg

Concrete headwall on LS toe.

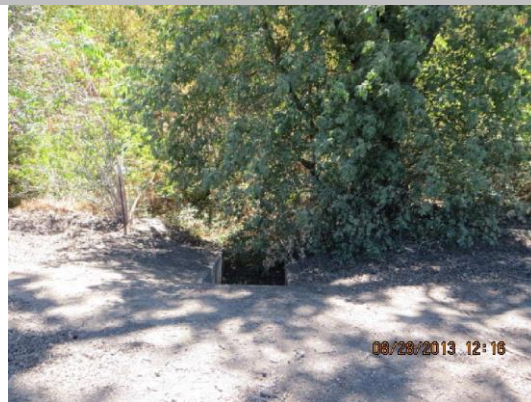
Photo 2 of 3 : UCIP\_SP\_2018\_19120\_32078.jpg

Concrete headwall on WS toe.

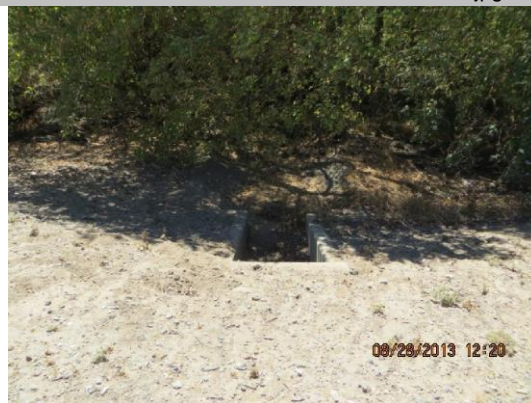
Photo 2 of 3 : UCIP\_SP\_2018\_19122\_32082.jpg

Concrete headwall on WS toe.

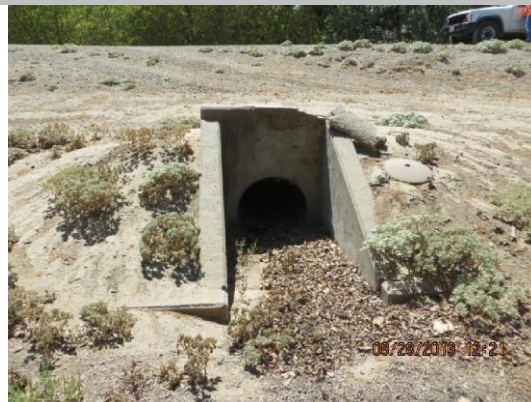
Photo 3 of 3 : UCIP\_SP\_2018\_19122\_32081.jpg

Concrete headwall on LS toe.

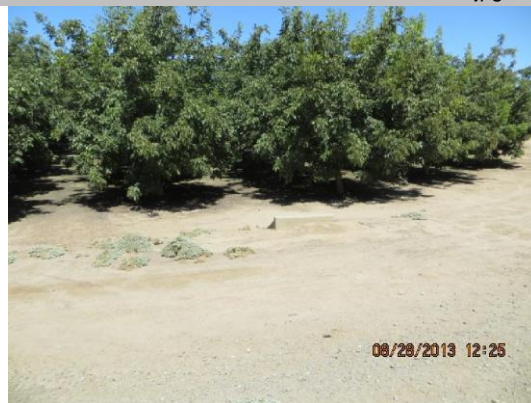
Photo 1 of 3 : UCIP\_SP\_2018\_19143\_32122.jpg

Concrete headwall on LS toe.

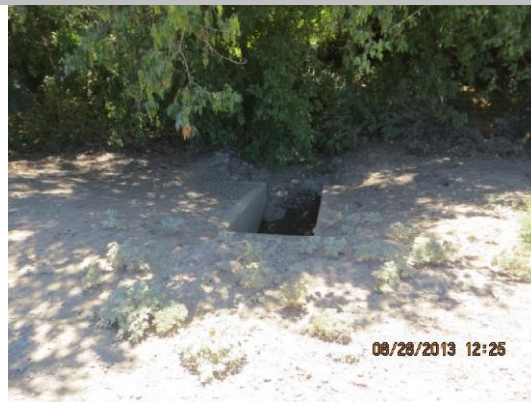
Photo 2 of 3 : UCIP\_SP\_2018\_19143\_32121.jpg

Concrete headwall on WS toe.

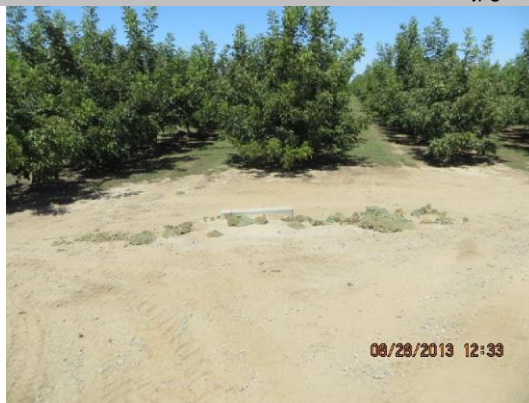
Photo 2 of 3 : UCIP\_SP\_2018\_22794\_38850.jpg

Concrete headwall on LS toe.
